## WEST HANTS REGIONAL MUNICIPALITY REPORT

Subject: **Halewood Dr Sinkhole and Infrastructure Emergency Remediation**

File No: 263070

**Re: Borehole Investigation – Halewood Drive, Falmouth, Nova Scotia**

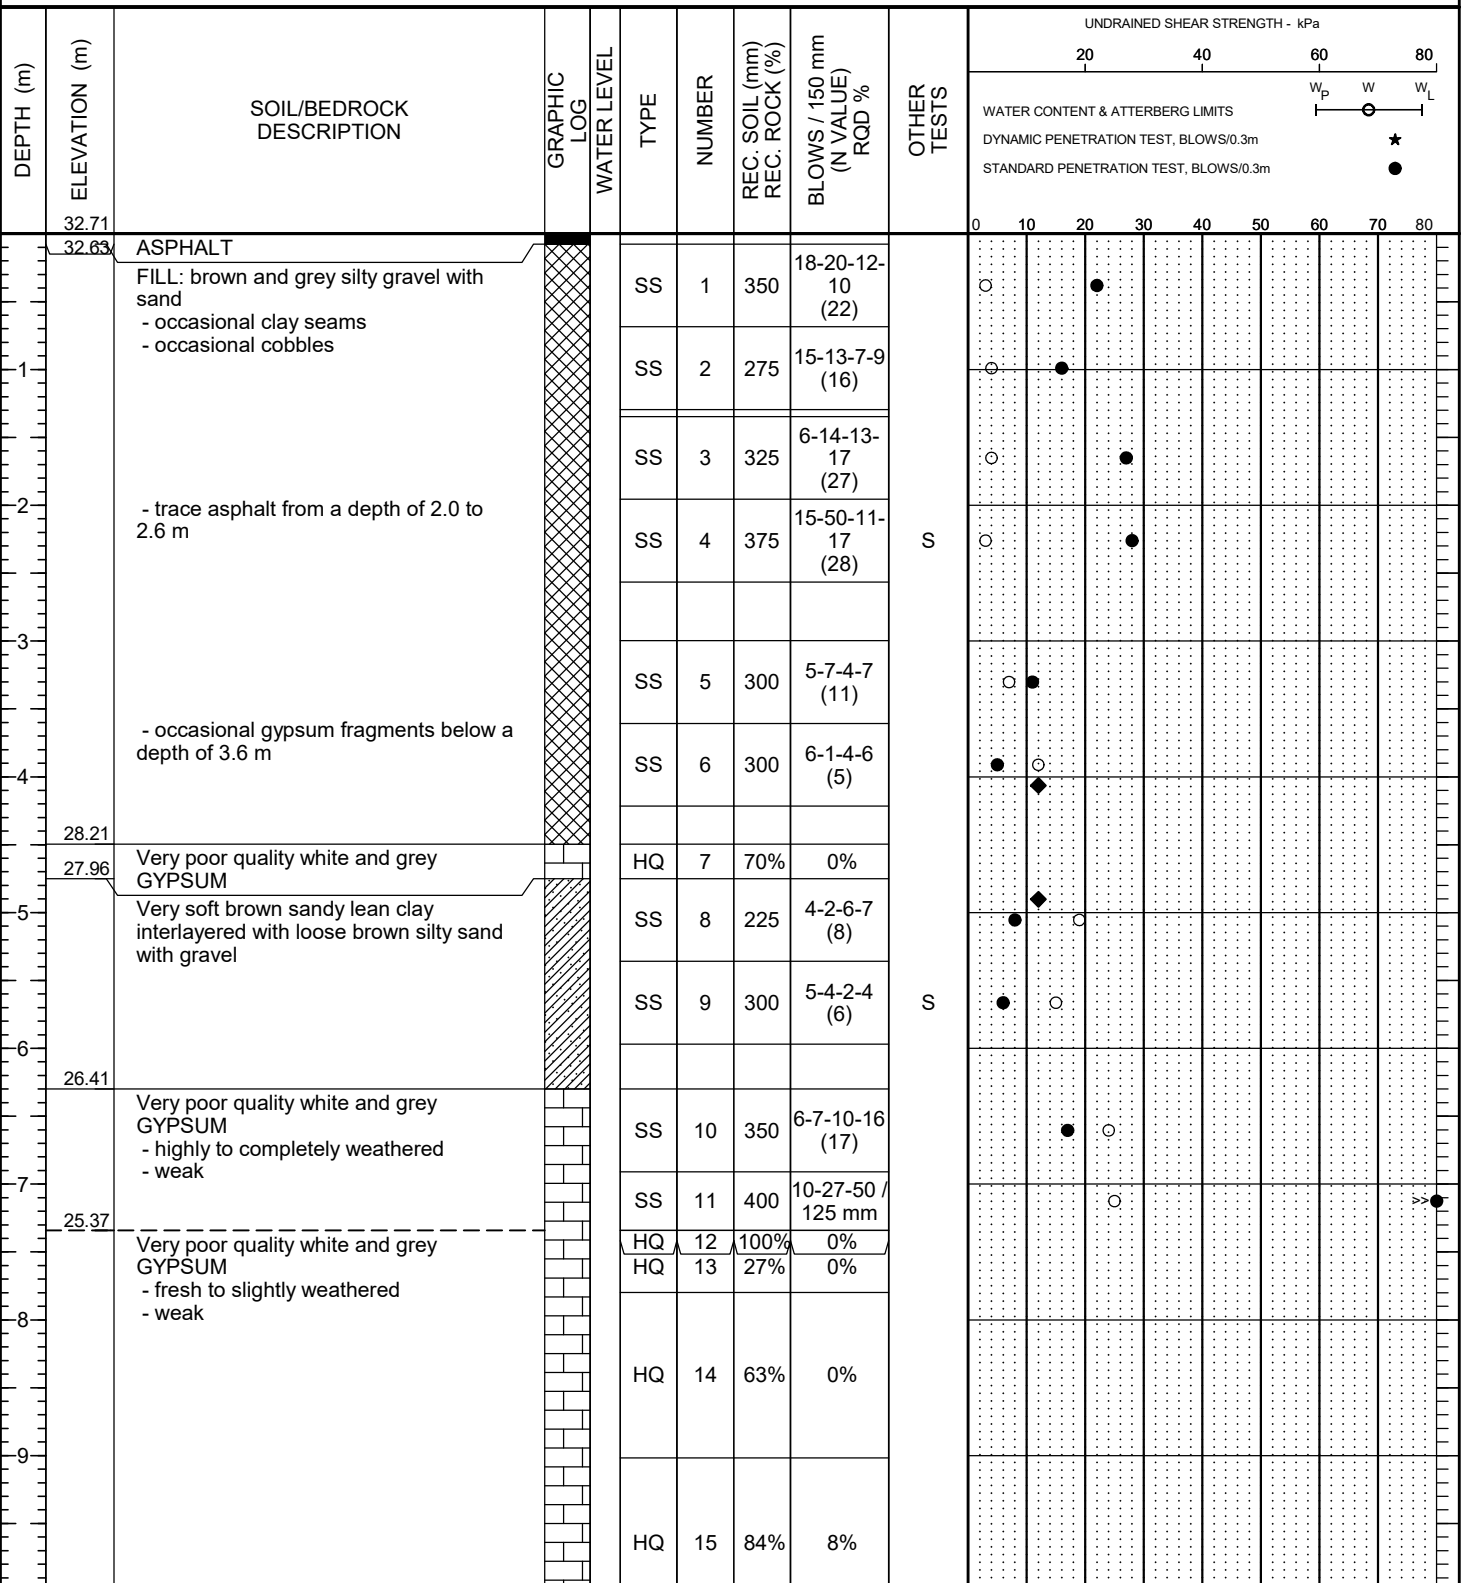
**BH01**

The subsurface conditions encountered at the borehole location generally consisted of asphalt, fill, and bedrock with infilled cavities. These conditions are described in additional detail on the attached Borehole Record.

The fill was approximately 4.4 m thick and consisted of silty gravel with sand, occasional clay seams, and cobbles. Below a depth of 3.6 m, gypsum fragments were occasionally recovered within the samples. While on site, discussions with West Hants Regional Municipality representatives indicated that a previous excavation to a depth of approximately 4.5 m had been completed during a maintenance event, which generally aligns with the borehole findings.

White and grey gypsum bedrock was encountered at a depth of 4.5 m. An approximately 1.6 m void, infilled with a loose matrix of sand and gravel with seams of softened clay, was encountered below the bedrock surface. Intact weathered bedrock was encountered below the void at a depth of 6.3 m, and competent bedrock was encountered at a depth of 7.3 m.

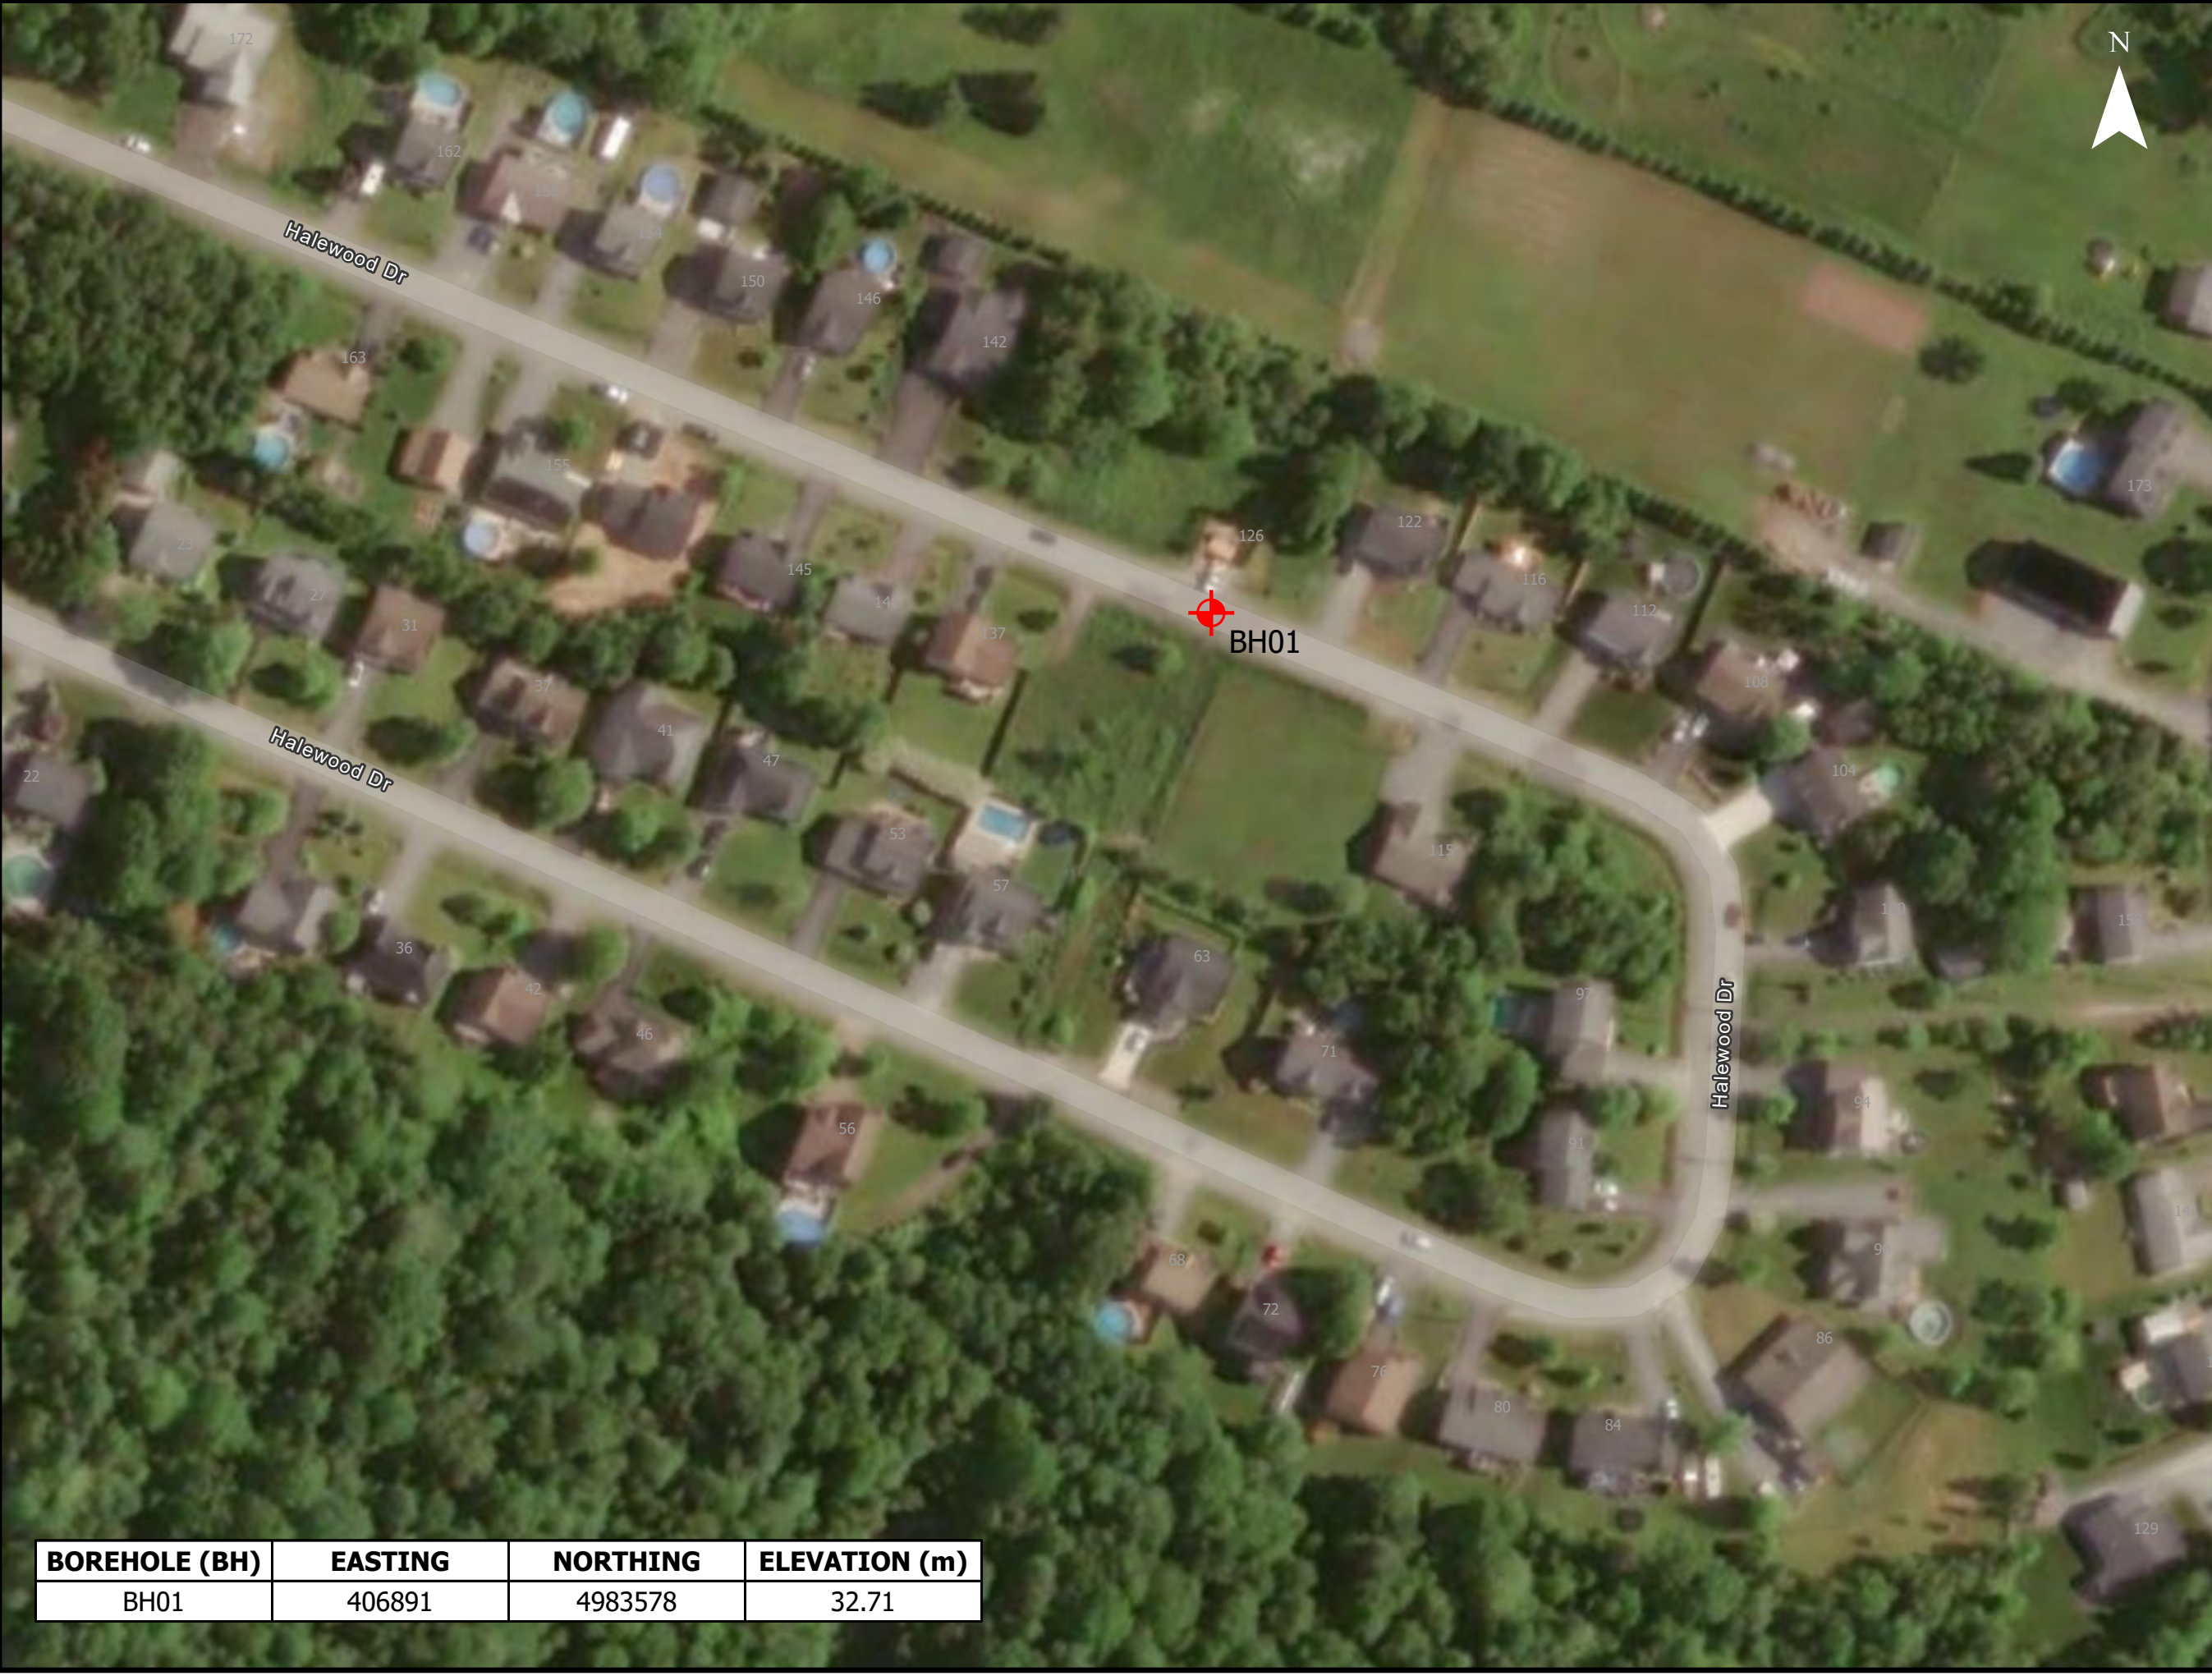
GEOTECHNICAL INVESTIGATION  
HALEWOOD DRIVE  
BOREHOLE LOCATION PLAN

The field work was carried out on May 29, 2026. One borehole was advanced in the roadway opposite the above-noted address using a track-mounted CME-45 diamond drill equipped for geotechnical testing and sampling. The attached borehole location plan provides additional details regarding the test location. Harbourside personnel observed and logged the subsurface conditions at the borehole location, which was advanced to a depth of 12.7 m below ground surface.
